# Aviation Investigation Final Report

| <b>Location:</b> | Cabazon, California | <b>Accident Number:</b> | WPR23FA302 |
| <b>Date &amp; Time:</b> | August 6, 2023, 18:44 Local | <b>Registration:</b> | N555AS (A1);<br>N4037S (A2) |
| <b>Aircraft:</b> | Bell 407 (A1); Sikorsky S-64E (A2) | <b>Aircraft Damage:</b> | Substantial (A1);<br>Minor (A2) |

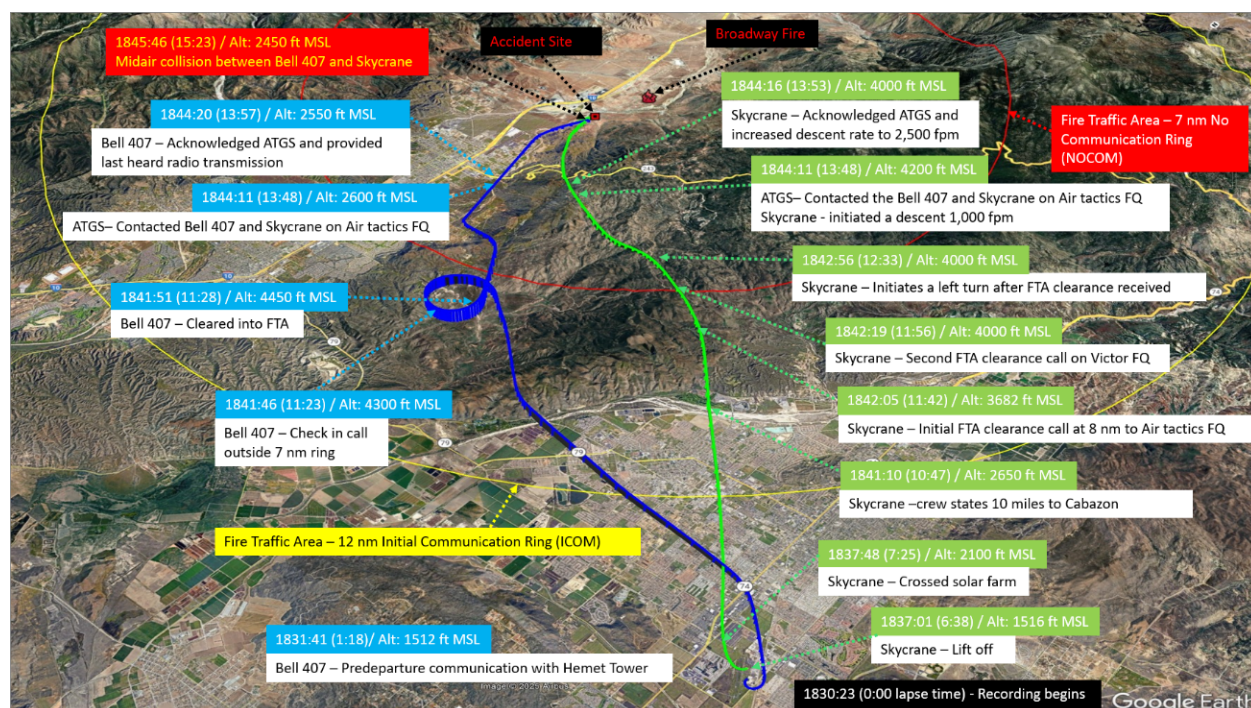
Review of the communication recording from within the Skycrane shows that the recording started at 0:00 lapse time (refer to figure 1).

Figure 1. Recorded ADS-B data with select communications annotated.
